Ultrasound Localization and Removal of Impalpable ‘Lost Implanon’: Case Report

Türkiye Klinikleri J Gynecol Obst 2012;22(2):137-40

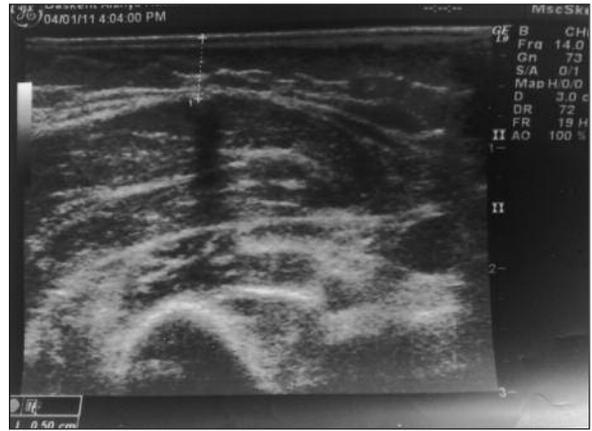
FIGURE 1a: Ultrasound showed that Implanon™ was located just above the muscle; 5-7 mm deep from the skin.

30-years-old woman, gravid 4, para 2, D&C 2 admitted to our outpatient clinic for non palpable Implanon™. She had been inserted Implanon™ 3 years before at a private clinic and she told us that the procedure was done easily without any problem and even she could palpate the Implanon™ at her left upper arm but she has not been palpate her Implanon™ since 4 months. At our examination we either could not palpate the Implanon™ at her left upper arm, it was clear that it was not in the subcutis. Afterwards, US was performed, US showed that Implanon™ was migrated nearly 10 cm cranially and it was located just above the muscle; 5-7 mm deep from the skin and this point was marked (Figure 1a). We planned to remove the Implanon™ in the operating room; then informed consent was obtained. Under general anesthesia a 5 mm incision was made over the upper arm where we marked at US, and then we reached the Implanon™ below the fascia muscularis, we removed it by using pop out technique and forceps (Figure 1b). There was no important bleeding and the operation was ended within 10 minutes. Postoperative period was normal and she was discharged at the same day.

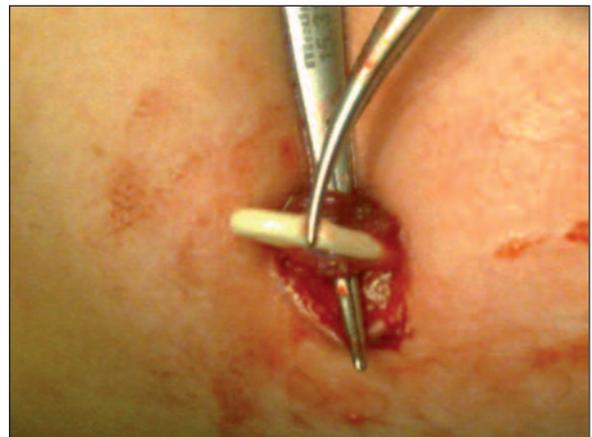
FIGURE 1b: Implanon was removed by using pop out technique and forceps. (See for colored from <http://jinekoloji.turkiyeklinikleri.com/>)
